STIMULAN[®]

PD 12 Kaulo pakaitalas Nr.6

STIMULAN is a truly absorbable calcium sulfate, specifically designed to complement your dead space management.⁸

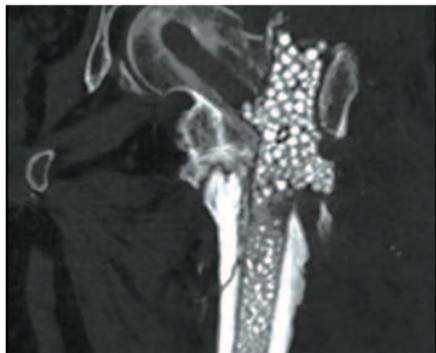
Infected subtrochanteric fracture⁹

Patient presented with: infected femoral nail and non-union of left femur with persistent discharging wounds proximally and distally.

Outcome: at 7 months' follow-up there was complete healing of the non-union and at 1 year patient remains infection free, walking with no pain.

35-year-old male involved in a road traffic accident suffered multiple injuries and subtrochanteric fracture of left femur. This was nailed, but subsequently, he developed infection and drainage from both proximal and distal locking screw areas. He went to theatre multiple times and developed wound approx. 15cm on the proximal lateral thigh, which was treated with VAC.

40cc of **STIMULAN** beads were placed in the intramedullary canal. Cultures revealed infection to be *Staphylococcus aureus*.

2.5 months' post-operatively x-rays showed almost complete absorption of the **STIMULAN** beads and at 7 months there was complete healing of the non-union.

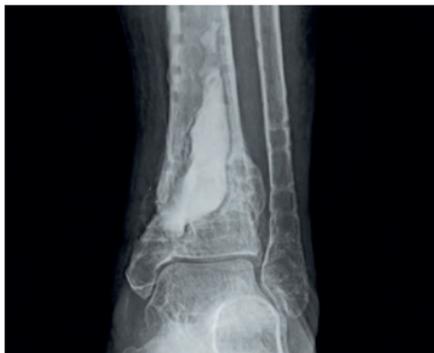
Osteomyelitis caused by group B *Streptococcus* and MRSA¹⁰

Patient presented with: drainage issues 1 year after pilon fracture repair and then 2 weeks after hardware removal.

Outcome: 6 months after treatment the patient was fully weight-bearing and without restrictions on activity – with complete absorption of STIMULAN.

73-year-old female with osteomyelitis caused by group B *Streptococcus* and MRSA infection. Presented with exposed hardware and post-operative drainage issues, 1 year after pilon fracture repair and subsequently 2 weeks after removal of all hardware.

Hardware removal and repeat debridement on the medial side of the ankle resulted in a large dead space which was managed using STIMULAN paste.

6 months after treatment the patient was free from infection, fully weight-bearing and without restrictions on activity – with complete absorption of STIMULAN paste.

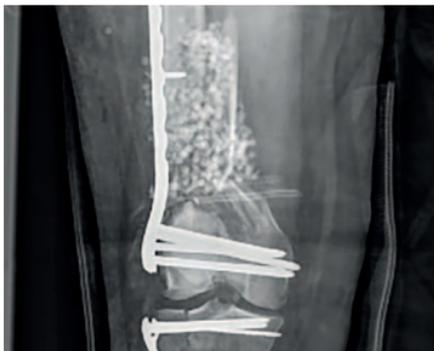
Bilateral high energy femoral fractures¹¹

Patient presented with: right open comminuted distal femoral fracture and tibial plateau fracture, and left closed comminuted femoral shaft fracture.

Outcome: complete absorption of **STIMULAN** and healing of the femoral defect after 4 months. At 1 year, patient was fully independently ambulatory with no pain.

50-year-old female presented with bilateral high-energy fractures due to a motor vehicle accident with prolonged extrication. The patient suffered from right open comminuted distal femoral fracture and tibial plateau fracture and left closed comminuted femoral shaft fracture.

Day 3: The external fixator bridge was removed and open reduction internal fixation was performed on the distal femur. **STIMULAN**, cancellous allograft and demineralized bone were used to fill a significant bone deficit just above the femoral condyles. Antibiotic treatment was provided to prevent infection. Open reduction internal fixation was carried out for the tibial plateau fracture supplemented with the use of cancellous allograft.

4 months after treatment **STIMULAN** had absorbed and there was complete healing of the femoral defect.

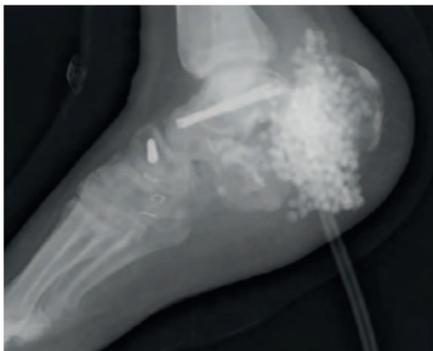
Open calcaneus fracture infected with MRSA¹²

Patient presented with: infected, MRSA positive non-union and hardware failure 6 months after treatment for an open calcaneus fracture.

Outcome: at 13 months the absorption of **STIMULAN** was complete, the patient was weight-bearing and without sign of infection – amputation was avoided.

40-year-old male sustained an open calcaneus fracture after a 20 foot fall. Initial surgery was an irrigation and debridement with definitive fixation 10 days after injury. 6 months later patient presented with an infected non-union and hardware failure. Cultures were positive for MRSA.

Hardware removal, debridement of grossly infected bone and soft tissues. STIMULAN was used to fill the resulting dead space. I.V. antibiotics for 8 weeks.

This patient is now weight-bearing as tolerated and clinically no signs of infection. Infection in open calcaneus fractures is common and in some series amputation rates exceed 50%. For this patient a 2 stage approach was utilized to treat the infected non-union. Removal of hardware and aggressive debridement of the bone. The dead space was managed with STIMULAN.

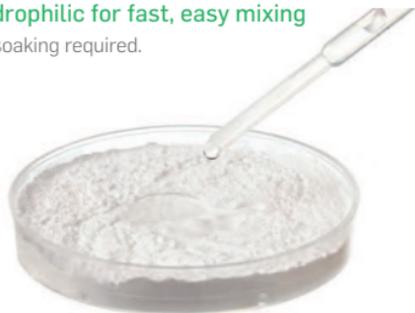
Hydrophilic for fast, easy mixing

STIMULAN — mixes with liquid

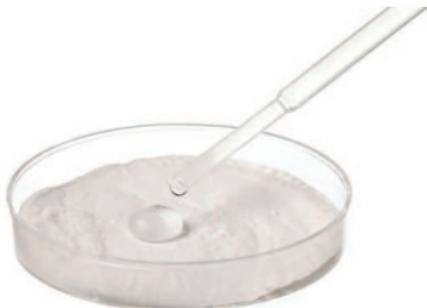
Competitor calcium sulfate — repels liquid

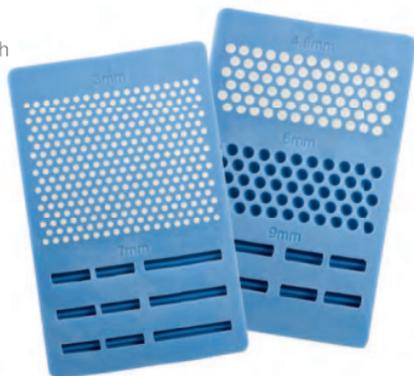
Introducing the NEW mini 3cc pack size and combination bead and bullet mat for smaller void volumes.

The new combination bead and bullet mat is only available with the 3cc pack size

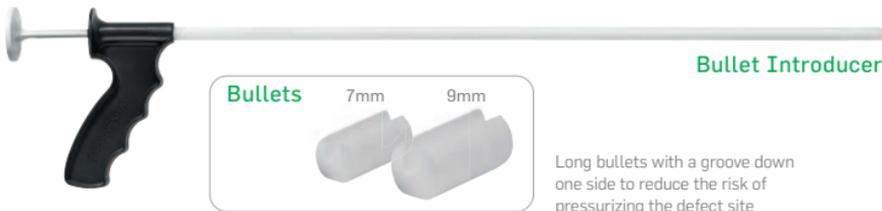
STIMULAN Bullet Mat and Introducer

Streamlined, flexible design that simplifies the delivery of **STIMULAN** for deep defects.

Bullet dimensions	Reamed diameter	In the pack	Order code
7mm x 20mm	10mm reamed diameter (minimum)	<ul style="list-style-type: none"> • Bullet mat • 7mm (black) inserter • 9mm (silver) inserter • Obturator 	660-001
9mm x 20mm	12mm reamed diameter (minimum)

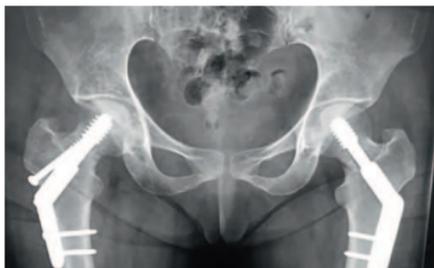
Initial post-operative

6 weeks after stage 1 treatment, the patient was free from infection with complete absorption of STIMULAN. 4 months after stage 2 treatment, the non-union site appeared to be healed with no hardware failure and complete absorption of STIMULAN. Imaging at 1 year after stage 2 treatment confirmed consolidation at the non-union site and stable hardware.

The sliding hip screw was removed from the left femur and multiple meticulous excisional debridements were performed. 20cc of STIMULAN paste was injected into the proximal femoral bone void. Bacterial cultures revealed *Propionibacterium Acnes*. Antibiotic treatment was administered based on the sensitivities of the organism and I.V. antibiotics were administered for 6 weeks following surgery.

At 6 weeks, autologous bone graft and 10cc of STIMULAN paste were placed at the femoral neck non-union site. Internal fixation was performed with a blade plate device.
